# HIGHWAY RESEARCH REPORT

## Study of Lime Treated Sections on Road 10-SJ-580,132

**NO. M & R 633189**

A REPORT ON  
STUDY OF LIME TREATED  
SECTIONS ON ROAD  
10-SJ-580,132  
NEAR TRACY, CALIFORNIA

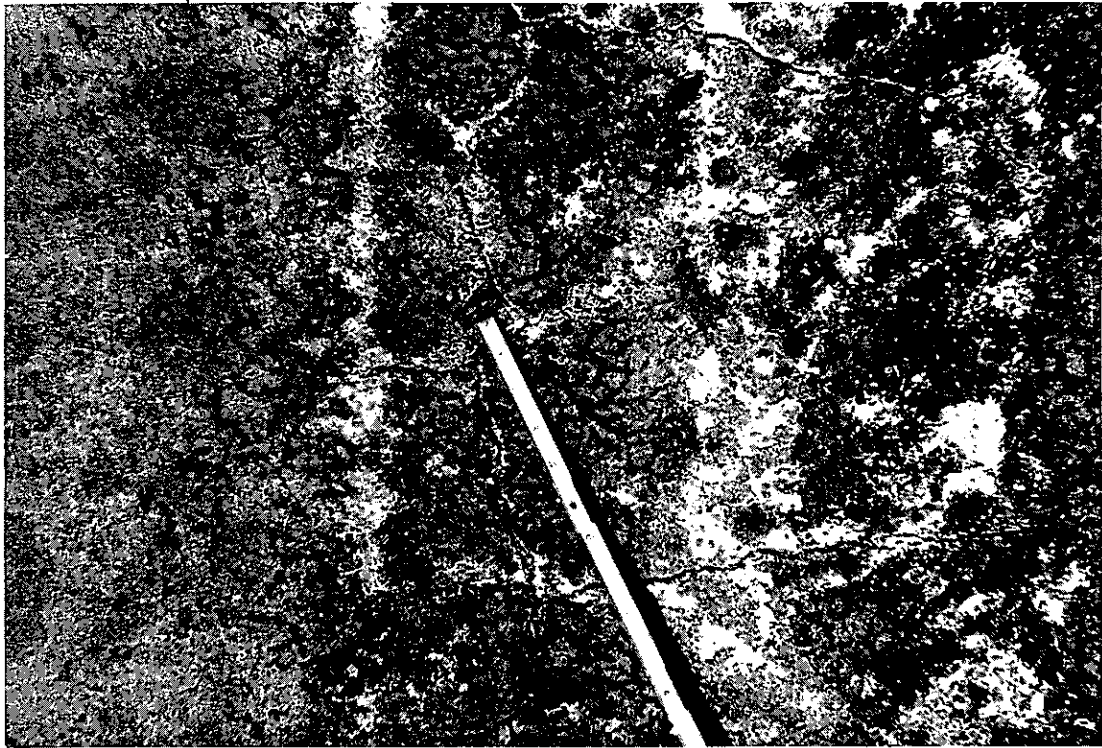
FIGURE 3A

The cracking was probably due to drying and consequent shrinking of the lime treated material. As a comparison, Figure 3B shows cracking in the native soil. The extensive cracks indicate the clayey nature of the soil. The northbound lanes were also treated with 4% lime at a moisture content of about 32%. It was not known if this section also cracked since the subbase layer was placed shortly after the lime treatment. This work was performed during March, 1965.

Crack pattern in the lime treated soil.

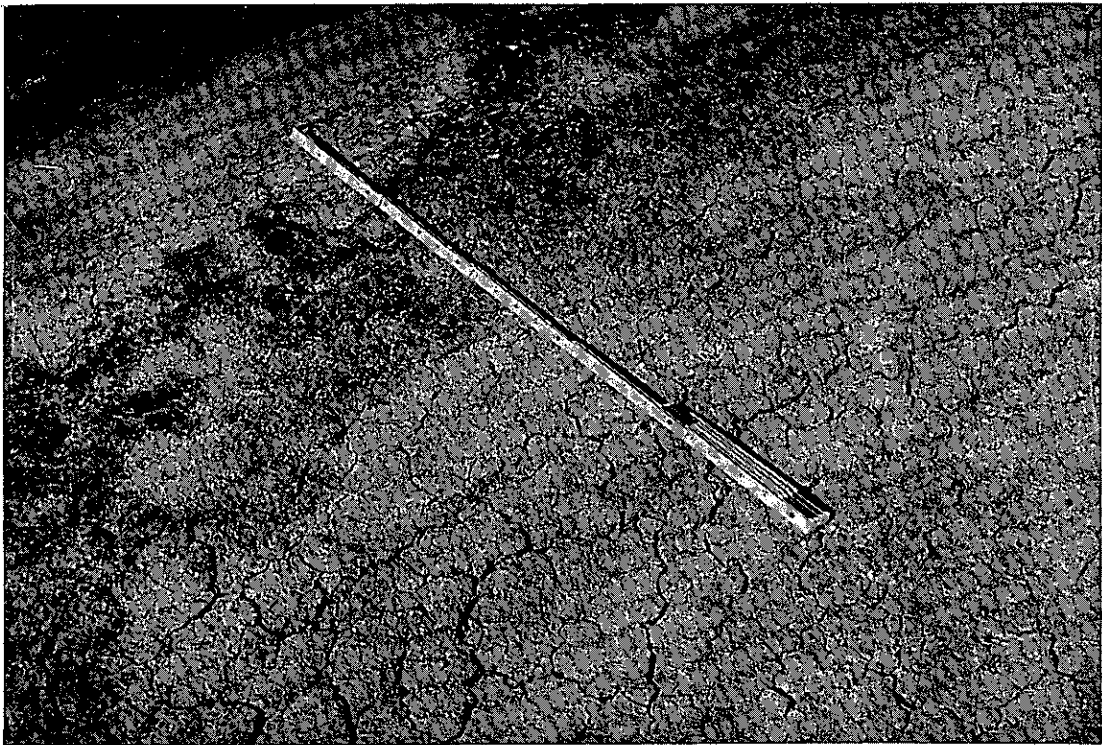
FIGURE 3B

Crack pattern in the untreated soil along the shoulder.

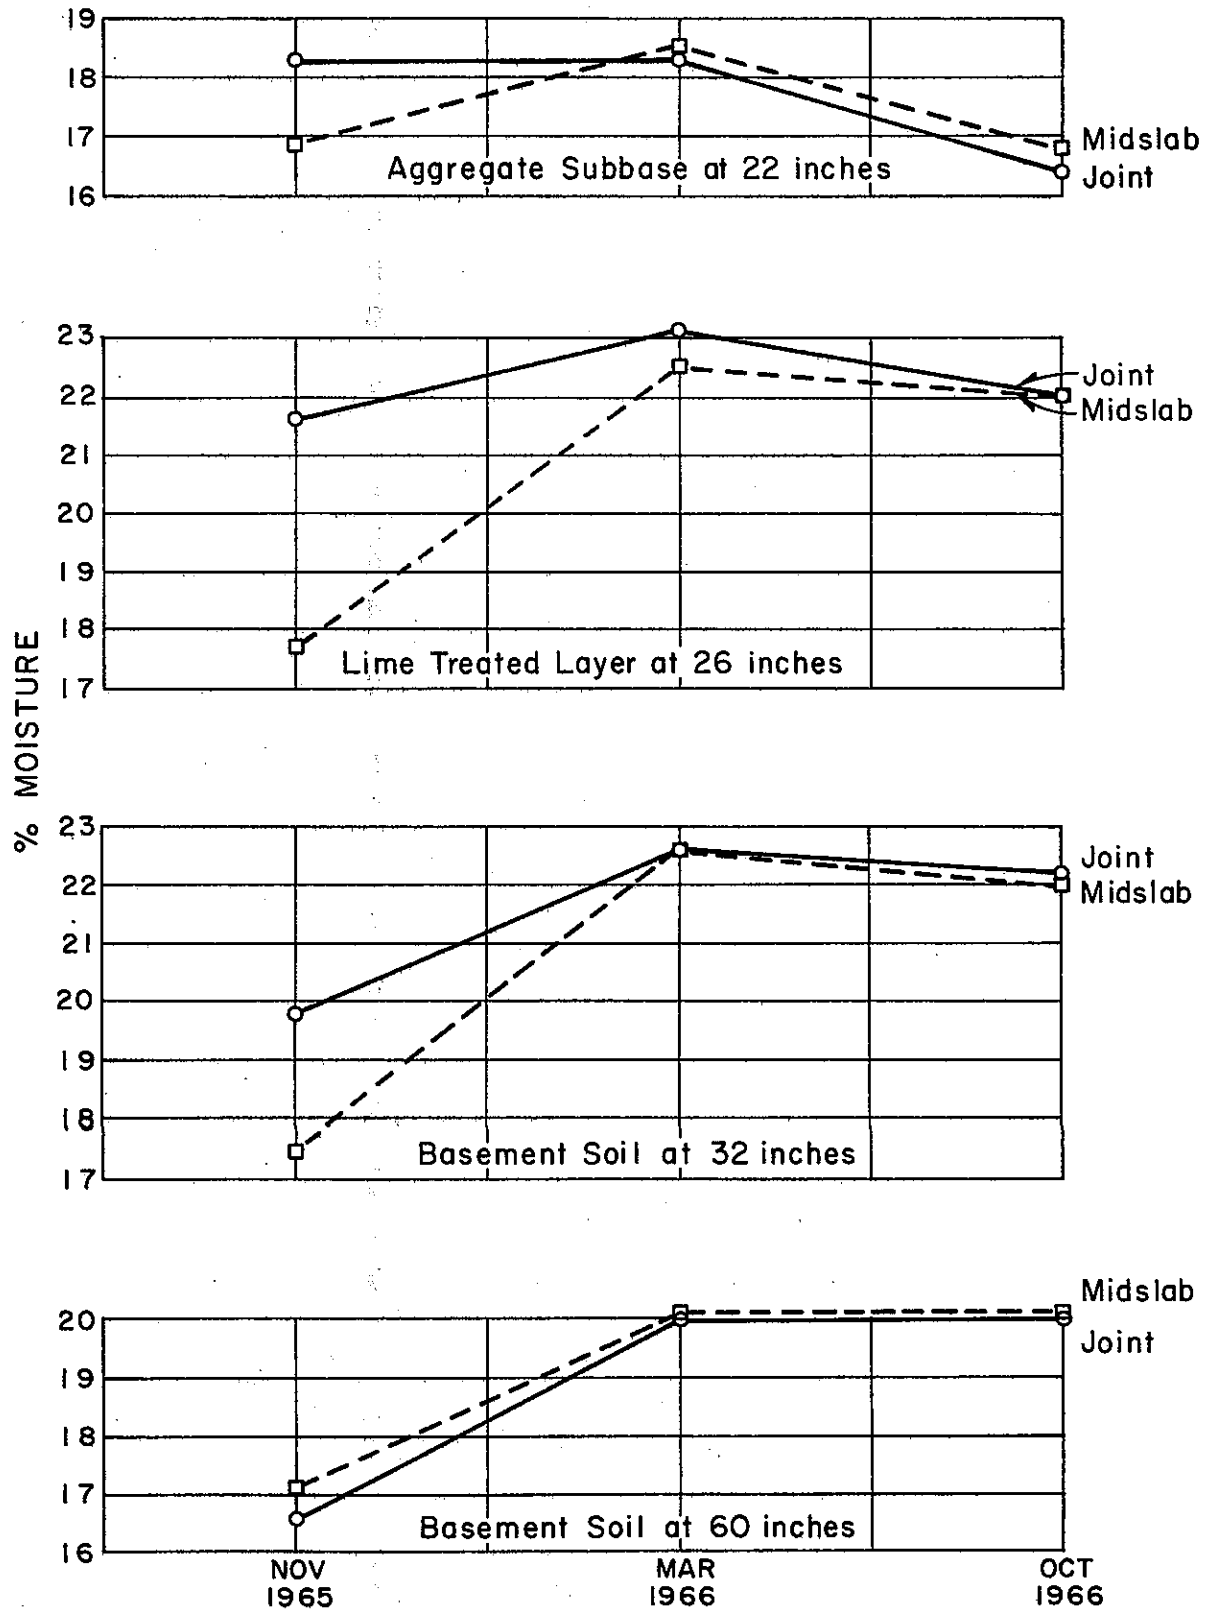
Figure 6

1. The aggregate subbase in the lime treated section (Figure 6) shows a much higher moisture content than in the untreated control sections (Figures 7 and 8). This indicates that the lime treated layer is acting as an effective moisture barrier and preventing the surface water from entering the basement soil.

3. The basement soil moistures are considerably higher in the lime treated section than in the untreated control section. It is believed that this is due to the moisture vapor condensation phenomena that is occurring under the relatively impermeable lime treated layer. This is a desirable feature of lime treatment since uniform elevation of moisture in the basement soil minimizes PCCP curl or distortion

# AVERAGE PERCENT MOISTURE AT 4 LIME TREATED LOCATIONS 30" STRUCTURAL SECTION

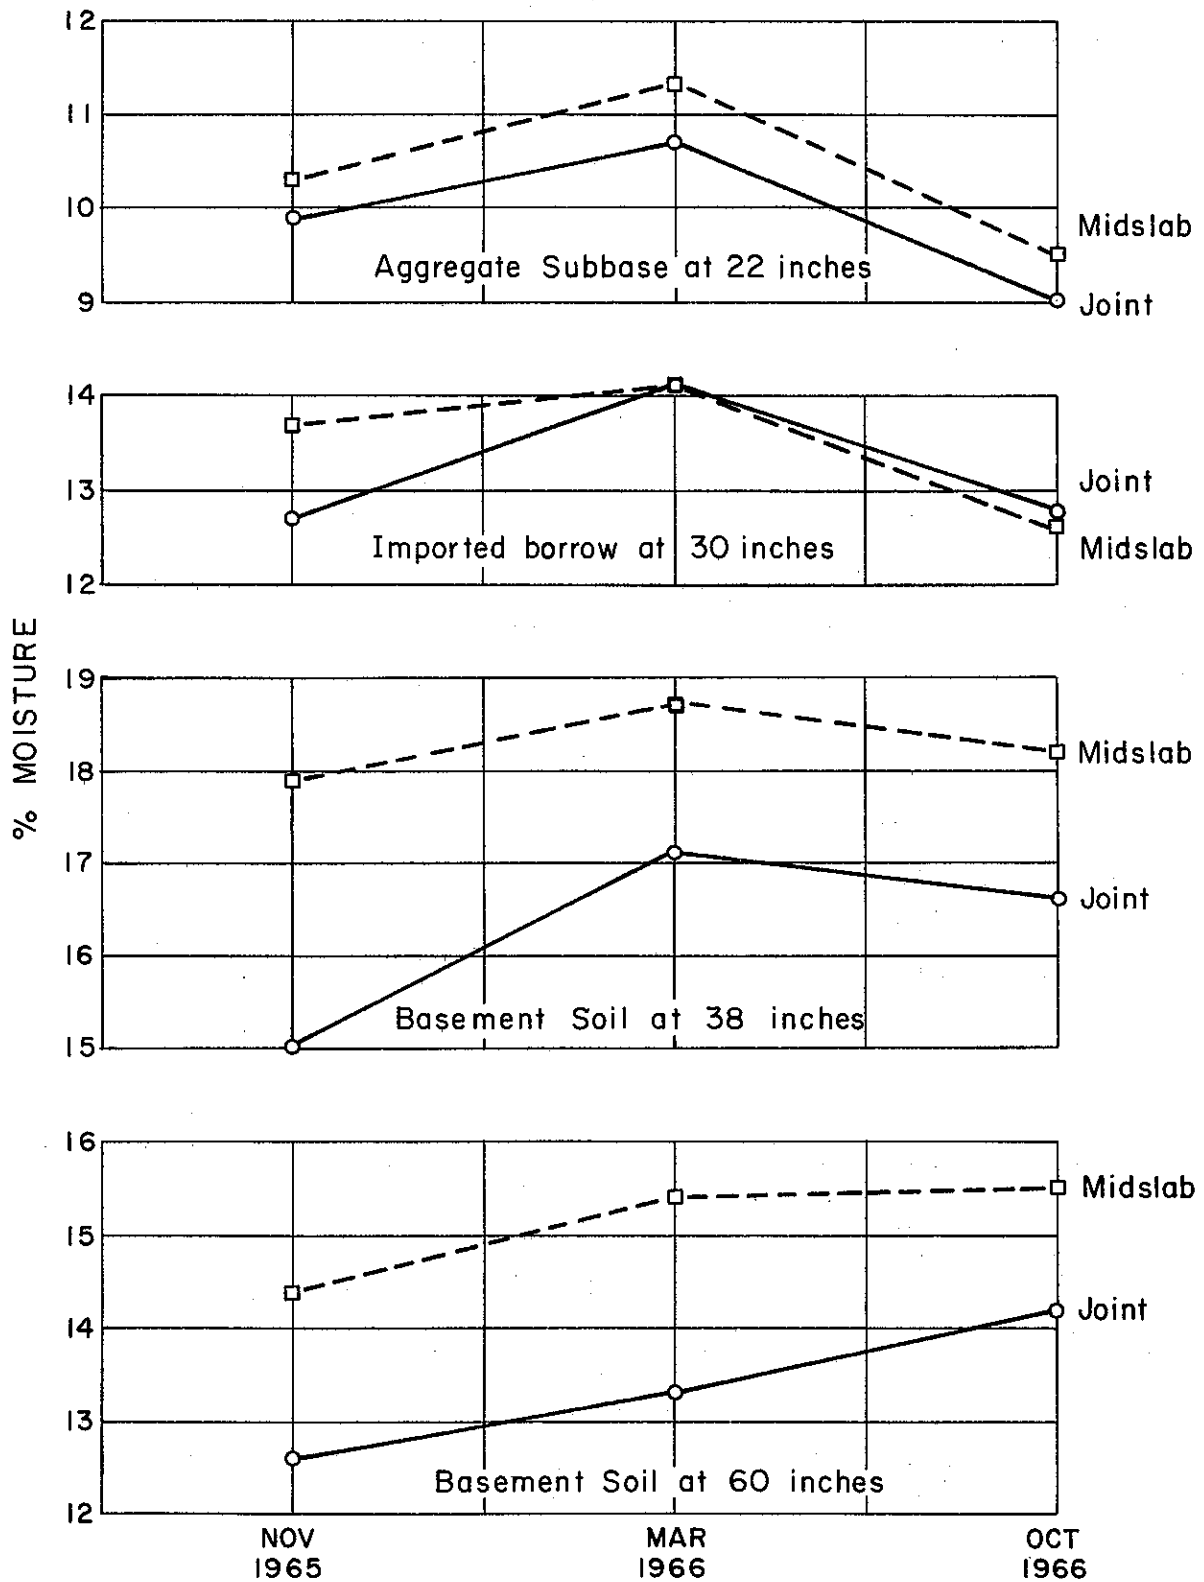
Figure 7

due to differential swelling. This phenomena does not occur in the untreated control sections since there is a 12" permeable layer of aggregate subbase directly over the fine grained imported borrow and basement soil.

# AVERAGE PERCENT MOISTURE AT 2 UNTREATED LOCATIONS

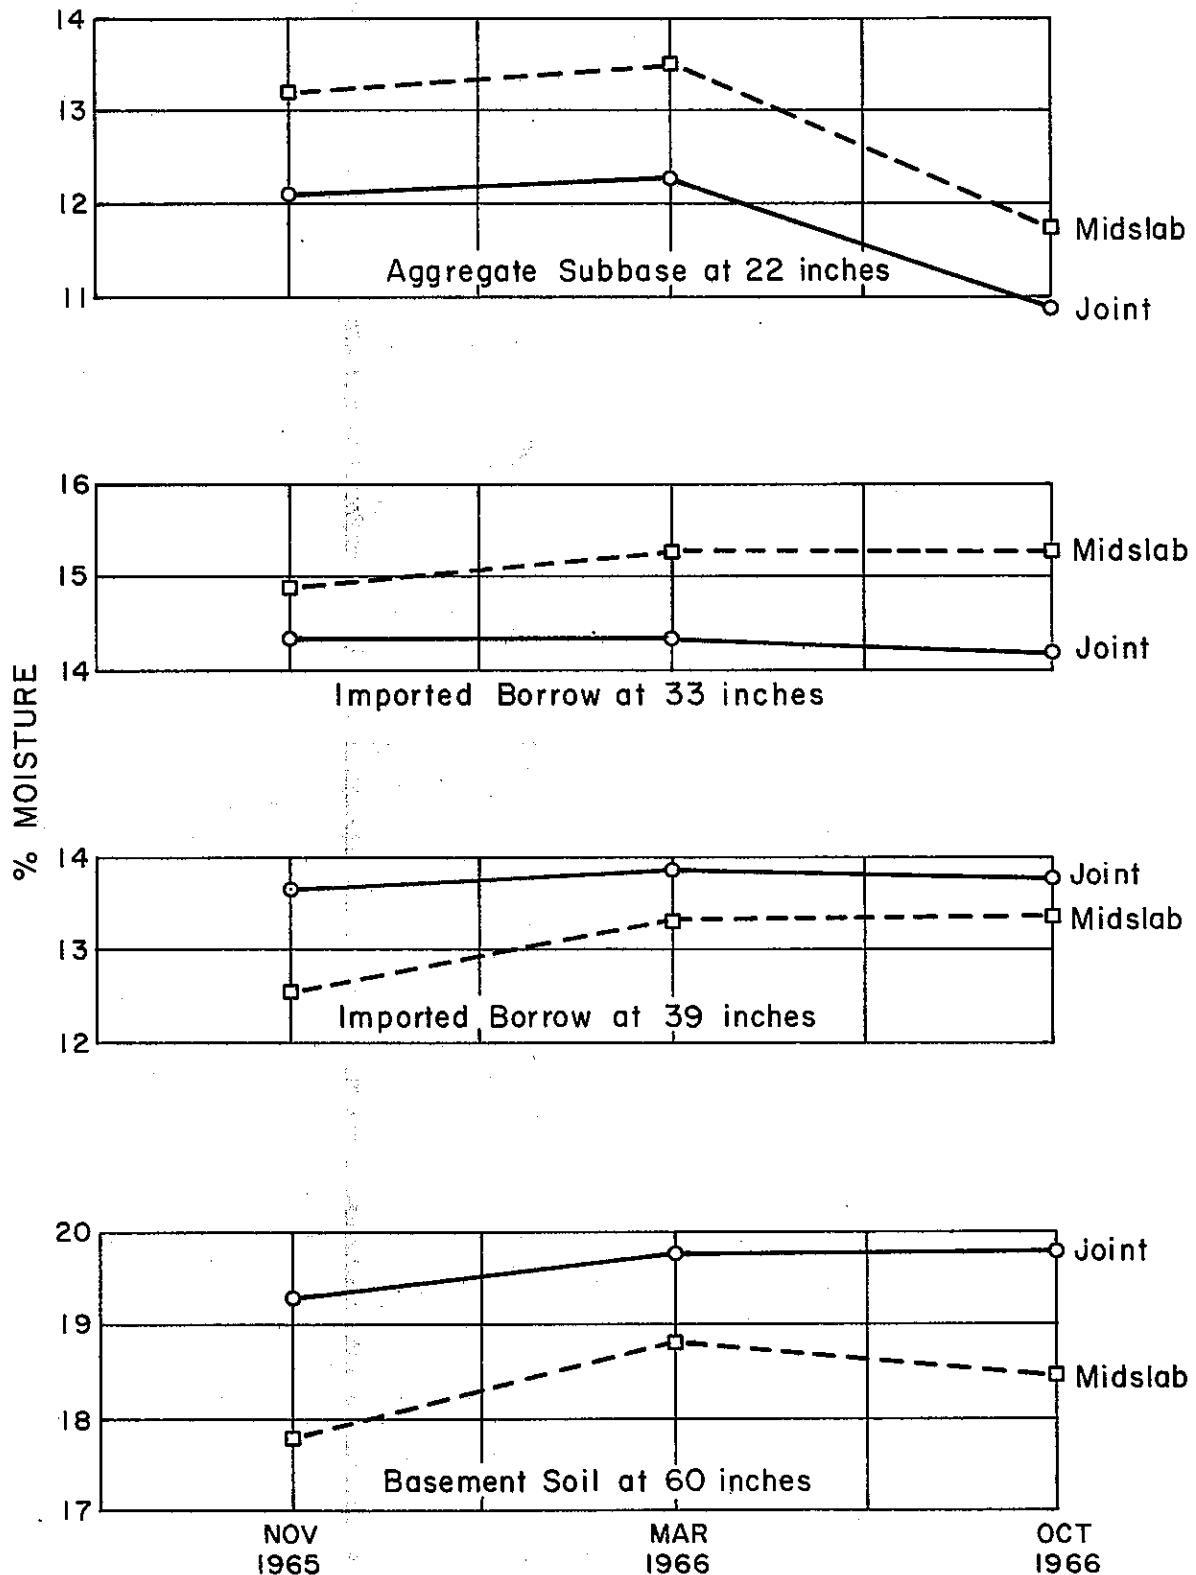
Figure 8

# AVERAGE PERCENT MOISTURE AT 2 UNTREATED LOCATIONS 4' CONTROL SECTION
